# CFS IT Closet / Server Rack Work Log – Bret Blackford

**Date:** April 15, 2026

**Location:** CFS

### CFS IT Closet / Network Equipment Work Performed — April 15, 2026

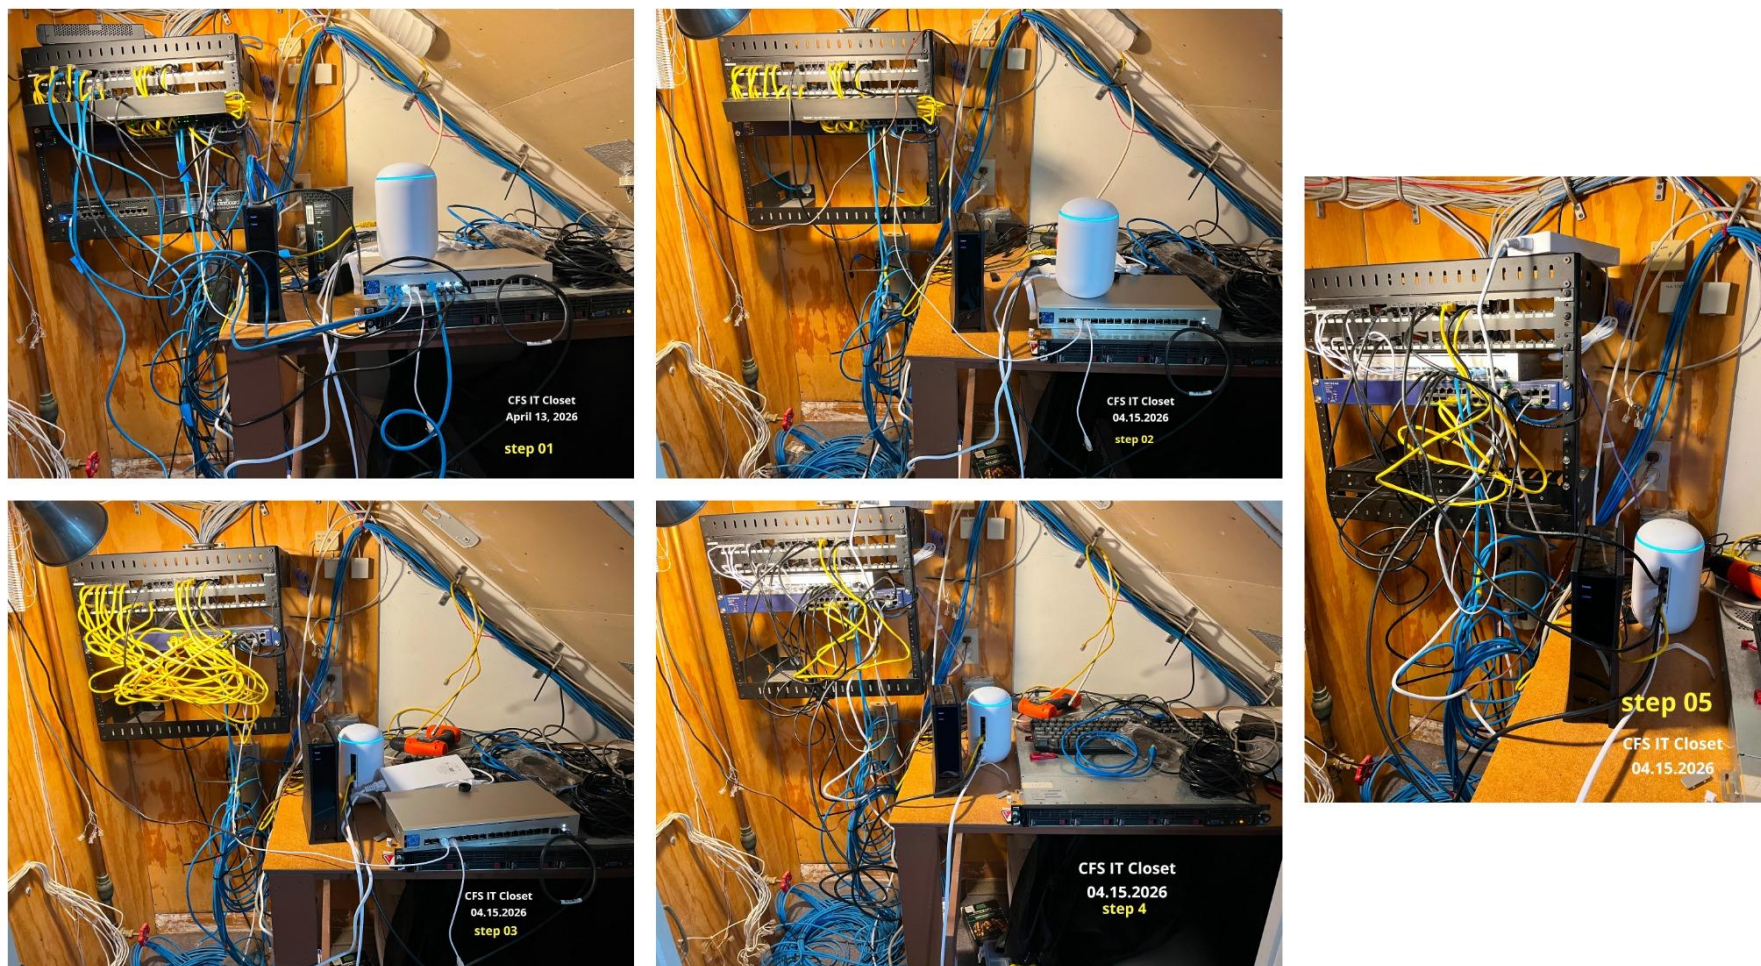
Attachment 1 — IT Closet Step Photo Collage

Before-and-after photos were also captured/documented. These photos show that the rack previously contained additional legacy networking hardware and now has a cleaner, more open layout, especially in the lower rack area. The UniFi environment now appears to be the primary active platform.

Primary visual exhibit for the memo. This collage shows the step-by-step progression of the IT closet/rack work and is the best single image for documenting cleanup progress, removal of legacy equipment, and the still-temporary cable state.
